# HOME INSPECTION REPORT

**123 SAMPLE STREET**

ANYWHERE, ONTARIO

Inspection Date: **January 1, 2016**

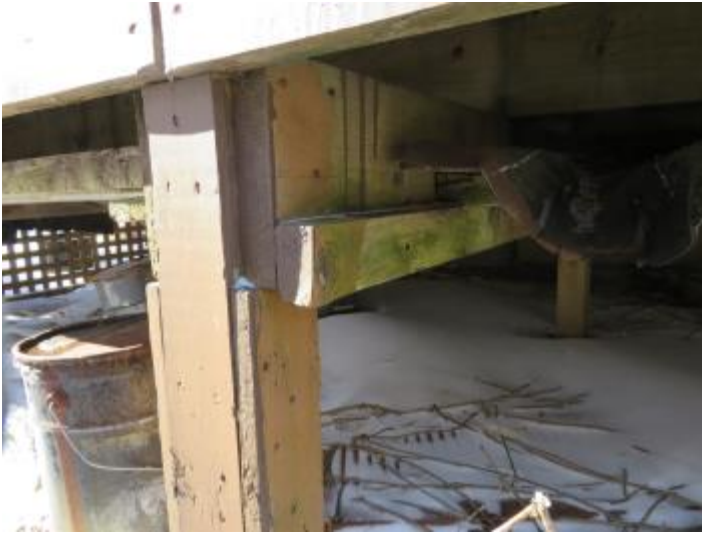
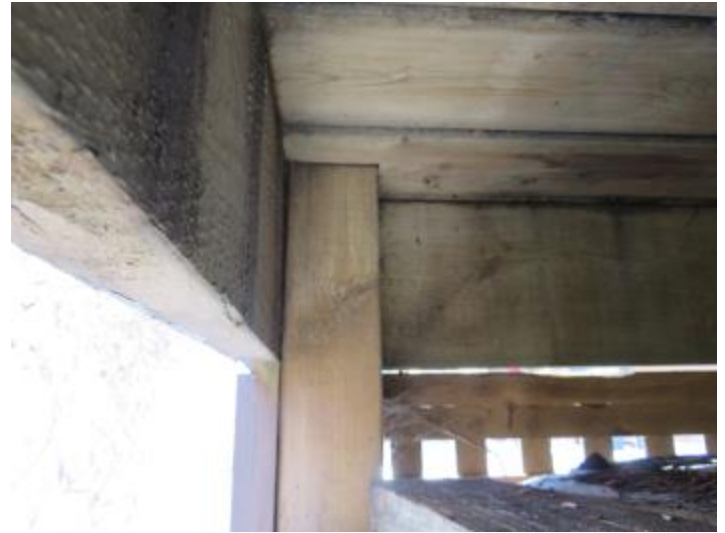
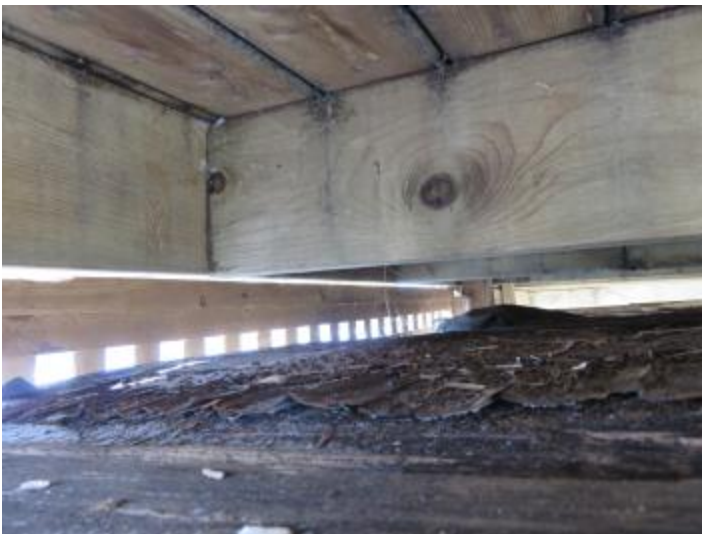
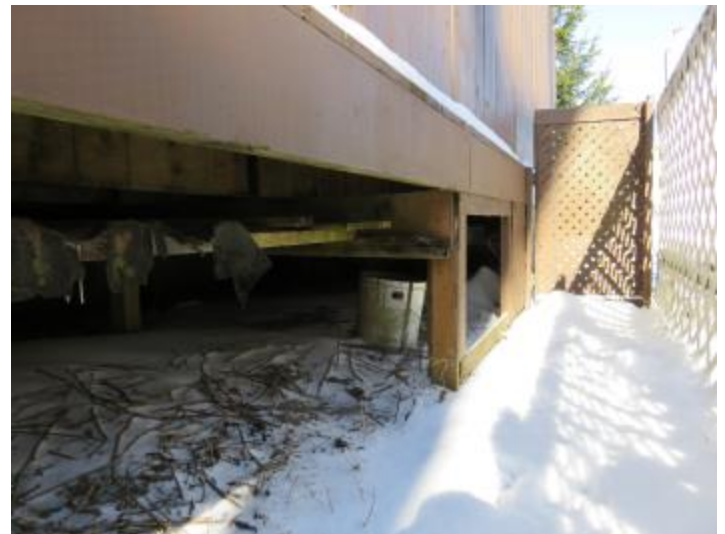
- The deck at the NE-side of the property was observed to have substandard construction. This may result in a potential safety hazard such as decks and/or porches separating from the building. Recommend that a qualified contractor repair or replace per standard building practices.

**Figure 1** *NE Deck Substandard Construction*

**Figure 2** *NE Deck Substandard Construction*

**Figure 3** *NE Deck Substandard Construction*

**Figure 4** *NE Deck Substandard Construction*

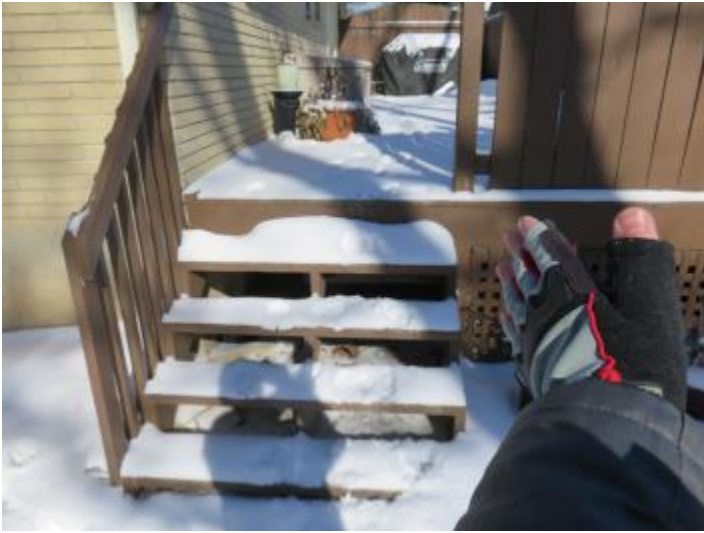
- The step(s) attached to the deck(s) at the NE-side of the property were observed to be missing a handrail. This is a potential fall hazard. Handrails should be installed at stairs with four or more risers or where stairs are greater than 30 inches high. Recommend that a qualified contractor install handrails where missing and per standard building practices.

**Figure 5** NE Deck Step(s) Missing Handrail

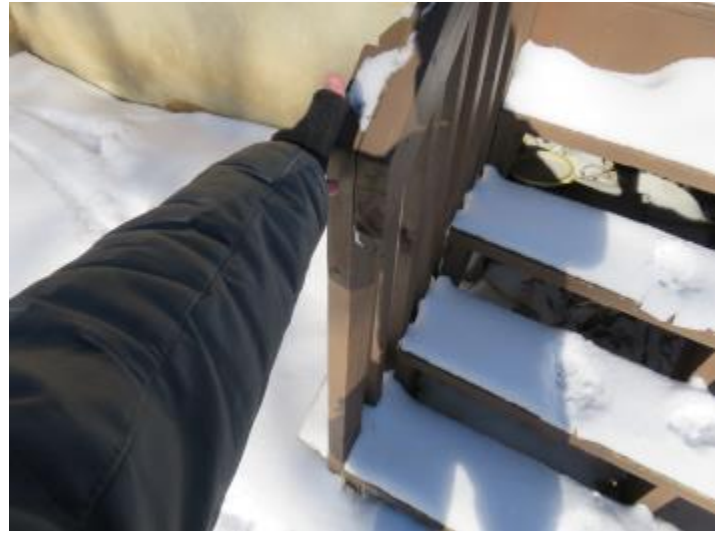
- Posts for the handrail(s) of the deck(s) at the NE-side of the property were observed to be missing or substandard. This poses a safety hazard. Posts for handrail(s) and guard(s) should be located at each end or termination of a handrail or guard. Recommend that a qualified contractor repair or replace post(s) per standard building practices.

**Figure 6** NE Deck Step(s) Handrail Missing Post

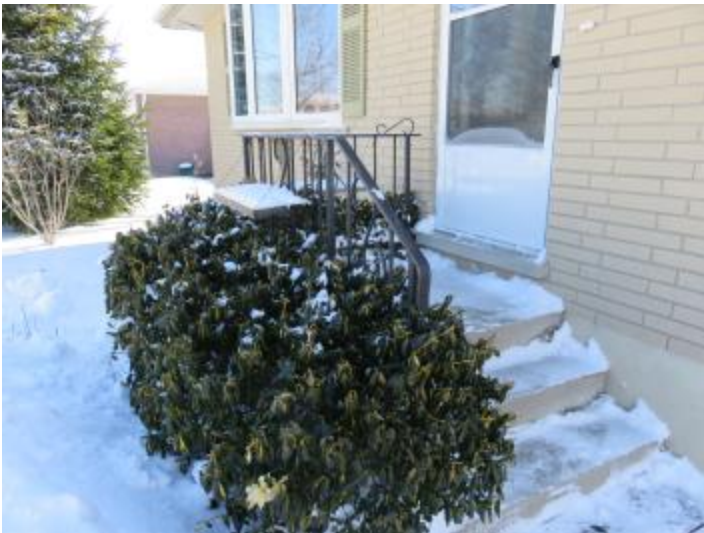
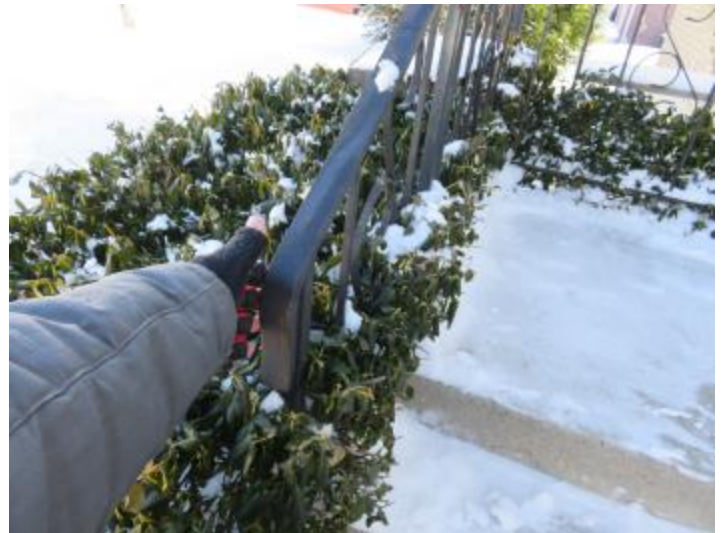
- Handrails or guards for the porch located at the front of the property were observed to be loose, damaged or substandard, and pose a fall hazard. Recommend that a qualified person repair or replace handrail(s) and guard(s) as necessary.
-

**Figure 7** Front Porch Handrail(s)/Guard(s) Loose

**Figure 8** Front Porch Handrail(s)/Guard(s) Loose

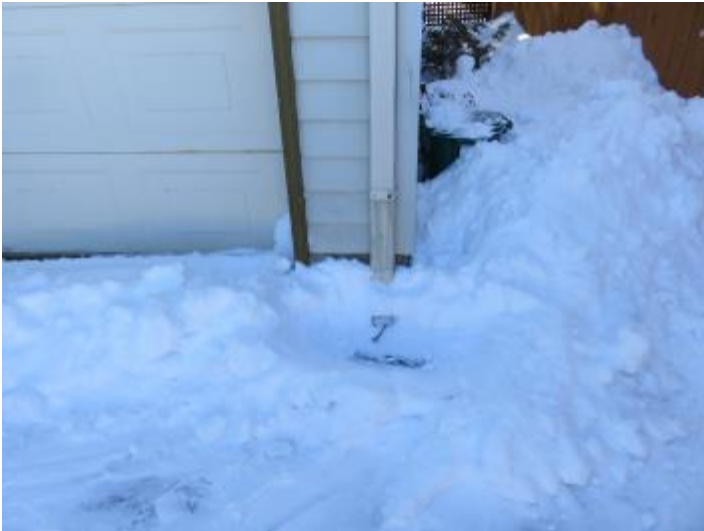
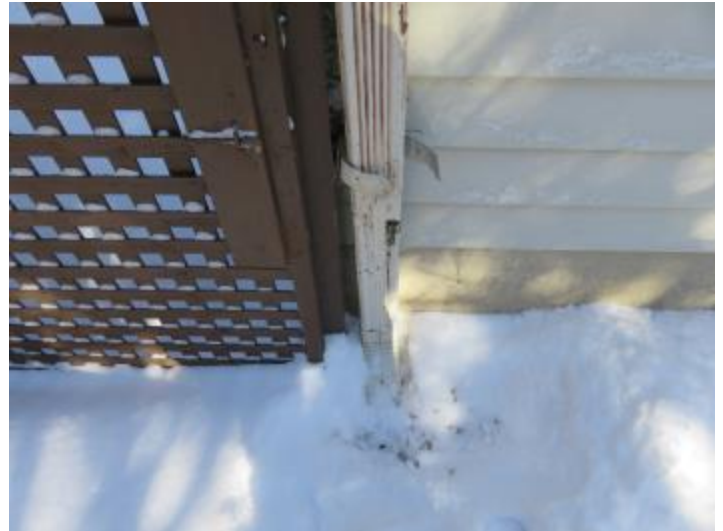
- Downspouts at the NW-corner of the building were observed to drain onto walkways. This can result in ice or moss forming on walkways, and can pose a fall hazard. Recommend that a qualified person install or modify extensions as necessary so rainwater isn't directed onto walkways.

- Extensions such as splash blocks or drain pipes for downspouts at the SW-corner of the building were observed to be missing, poorly sloped, misaligned, clogged, substandard or damaged. Water can accumulate around the building foundation or inside crawl spaces or basements as a result. Recommend that a qualified person install, replace or repair extensions as necessary so rainwater drains away from the structure.
-

**Figure 9** NW Downspout Discharging onto Walkway(s) **Figure 10** SW Downspout Missing Extension

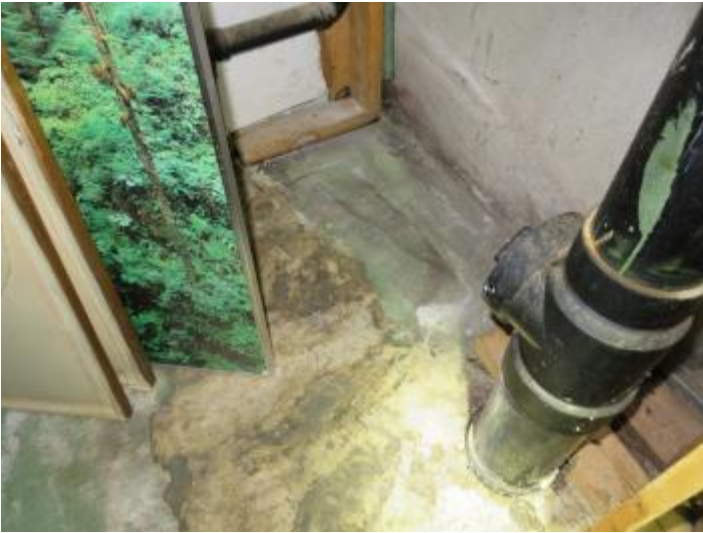
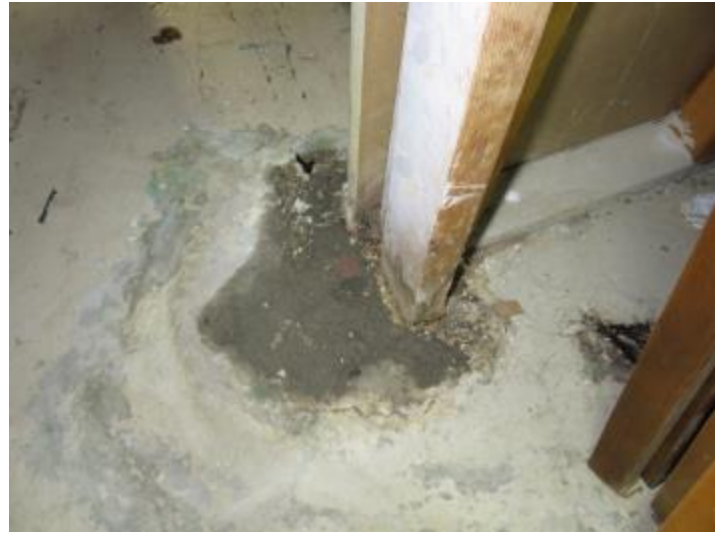
- Evidence of prior water intrusion was along the SW-facing interior foundation wall(s). For example, water stains or rust at support post bases, efflorescence on the foundation, etc. Accumulated water is a conducive condition for wood-destroying organisms and mold growth and should not be present in the basement. Recommend reviewing any disclosure statements available and ask the property owner about past accumulation of water in the basement. The basement should be monitored in the future for accumulated water, especially after heavy and/or prolonged periods of rain. If water is found to accumulate, then recommend that a qualified contractor who specializes in drainage issues evaluate and repair as necessary.

**Figure 11** Evidence of Moisture Intrusion at SW Wall(s)

**Figure 12** Evidence of Moisture Intrusion at SW Wall(s)

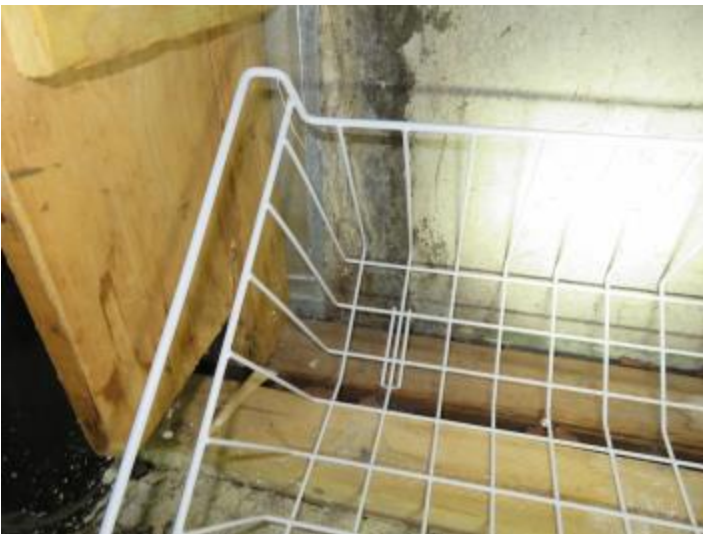
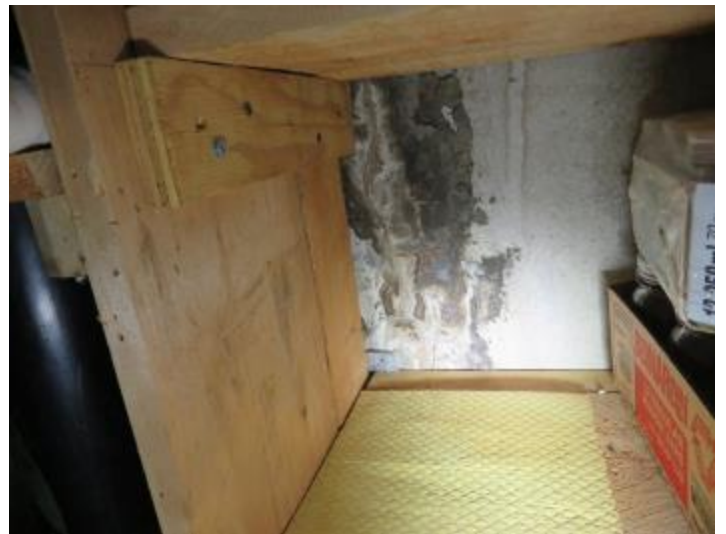
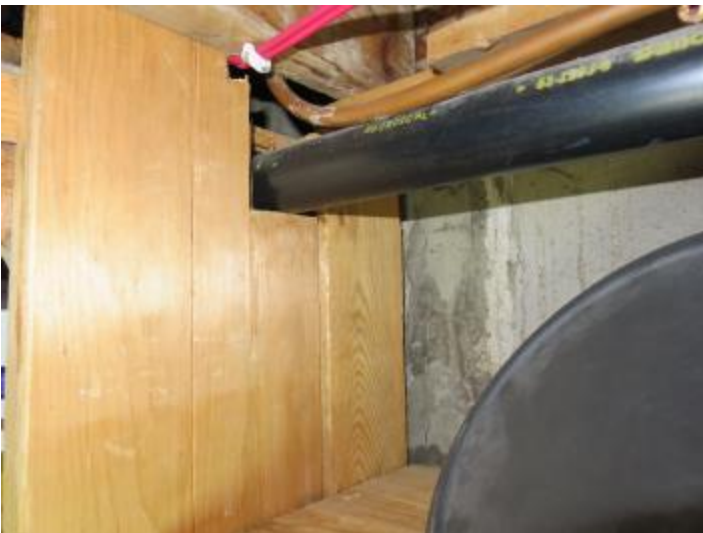
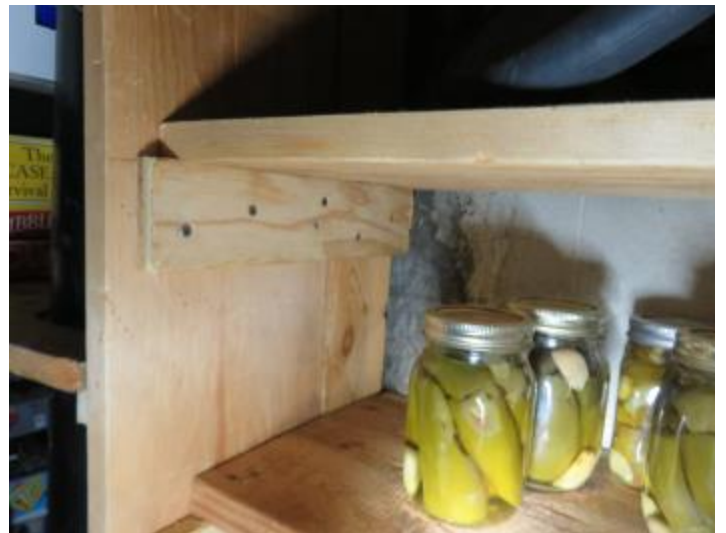
- One or more cracks in the SW-facing interior foundation wall(s) appear to have been repaired. This may indicate that water has infiltrated or accumulated in the basement previously, and/or that settlement is ongoing. Recommend consulting with the property owner and reviewing disclosure statements, and that a qualified contractor evaluate and repair if necessary. Note that the inspector does not guarantee or warrant that water will not accumulate in the basement in the future.

**Figure 13** Repaired Crack at SW Wall(s)

**Figure 14** Repaired Crack at SW Wall(s)

**Figure 15** Repaired Crack at SW Wall(s)

**Figure 16** Repaired Crack at SW Wall(s)

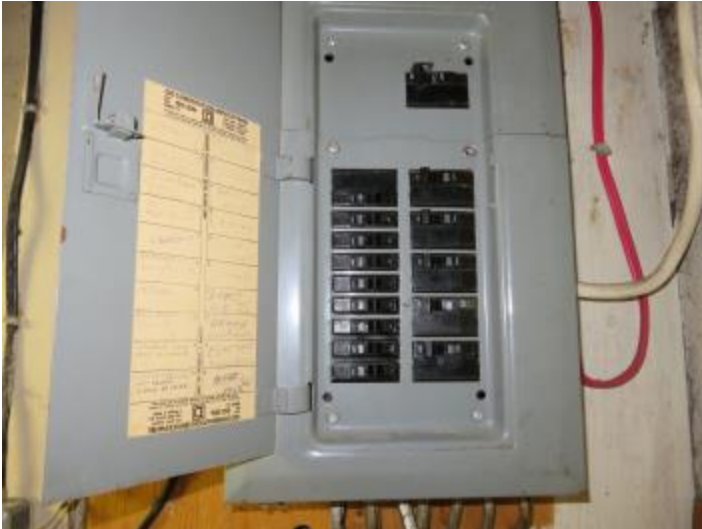
- The legend(s) for circuit breakers on the main service panel(s) was observed to be missing, incomplete, illegible or confusing. This is a potential shock or fire hazard in the event of an emergency when power needs to be turned off. Recommend correcting the legend so it's accurate, complete and legible. Evaluation by a qualified electrician may be necessary.

**Figure 17** Main Panel Legend(s) Substandard

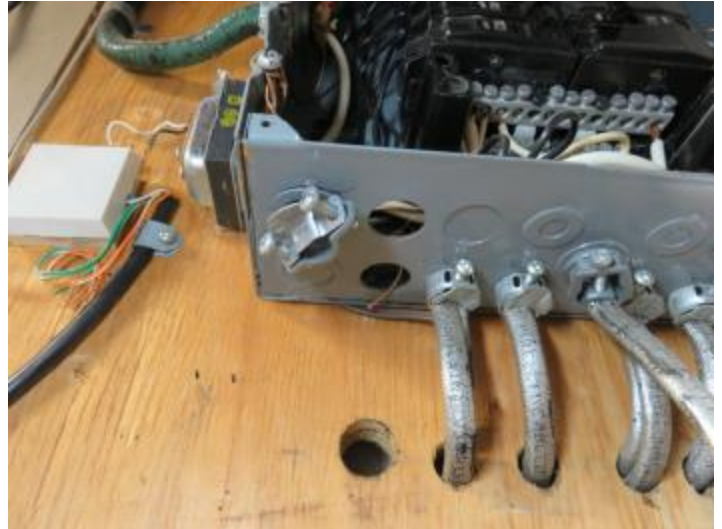
- One or more knockouts were observed to be missing from the main service panel. Holes in panels are a potential fire hazard if a malfunction ever occurs inside the panel. Rodents can also enter panels through holes. Recommend that a qualified person install knockout covers where missing and per standard building practices.

**Figure 18** Main Panel Missing Knockout(s)

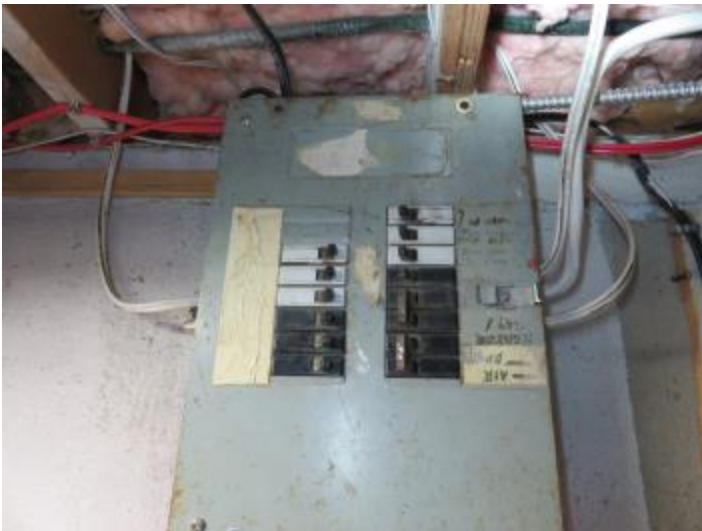
- The legend(s) for circuit breakers in the sub-panel(s) was observed to be missing, incomplete, illegible or confusing. This is a potential shock or fire hazard in the event of an emergency when power needs to be turned off. Recommend correcting the legend so it's accurate, complete and legible. Evaluation by a qualified electrician may be necessary.

**Figure 19** Sub-Panel Legend(s) Substandard

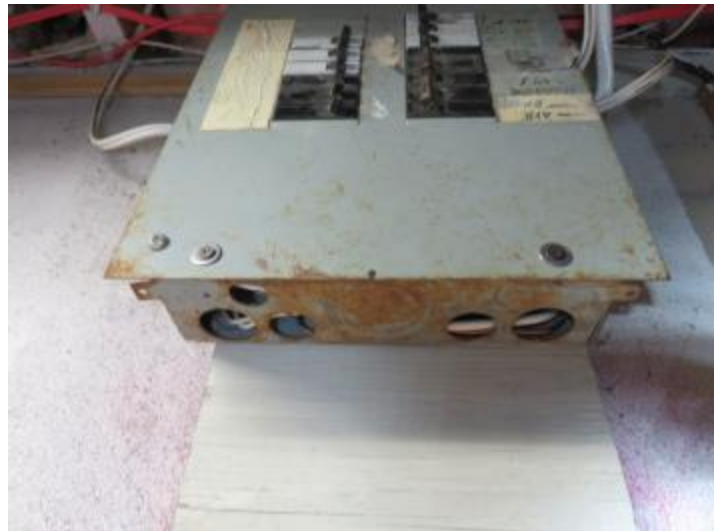
- One or more knockouts were observed to be missing from the sub-panel. Holes in panels are a potential fire hazard if a malfunction ever occurs inside the panel. Rodents can also enter panels through holes. Recommend that a qualified person install knockout covers where missing and per standard building practices.

**Figure 20** Sub-Panel Missing Knockout(s)

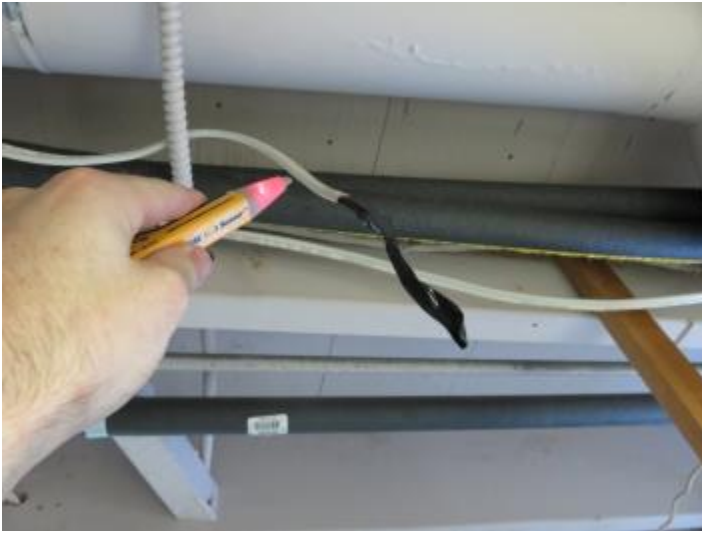
- Bare wire ends, or wires with a substandard termination, were observed at one or more locations in the laundry room. This is a potential shock hazard. Recommend that a qualified electrician repair as necessary. For example, by cutting wires to length and terminating with wire nuts in a permanently mounted, covered junction box.

**Figure 21** Wiring in Laundry Room not Terminated

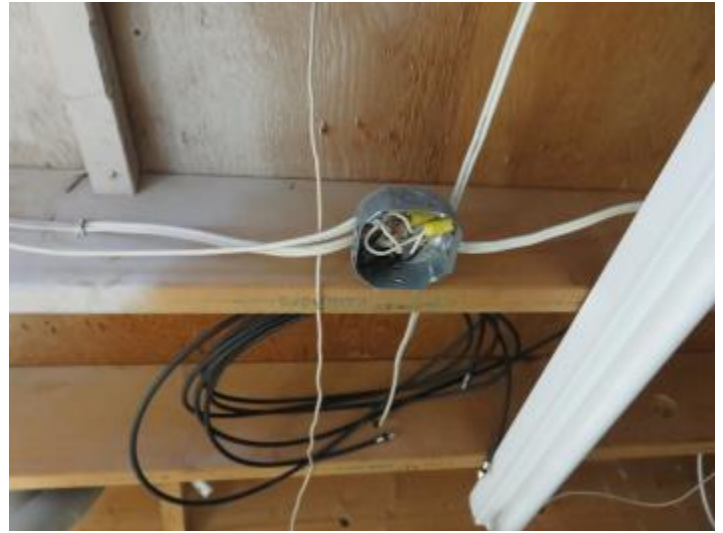
- One or more cover plates for junction boxes were observed to be missing or broken in the laundry room. These plates are intended to contain fire and prevent electric shock from occurring due to exposed wires. Recommend that a qualified person install cover plates where necessary.

**Figure 22** Laundry Room Junction Box Missing Cover

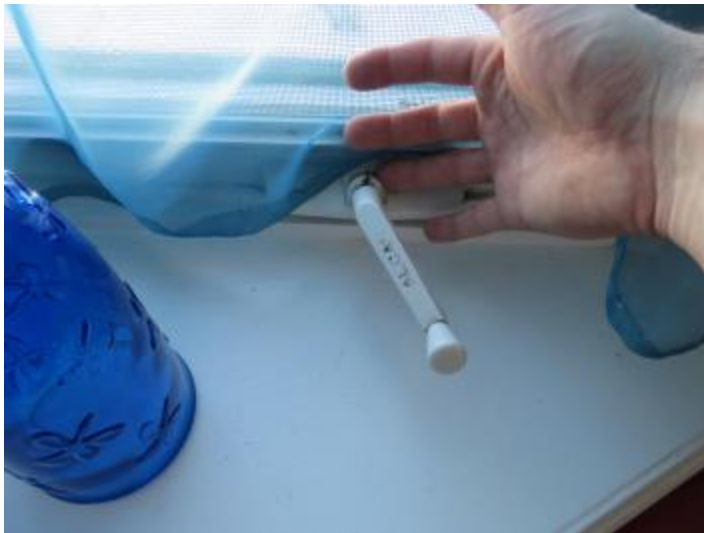
- One or more crank handles at the main level front windows were observed to be stripped, loose or broken. Recommend that a qualified person replace handles or make repairs as necessary.

**Figure 23** Crank Handle(s) Broken at Front Window(s)

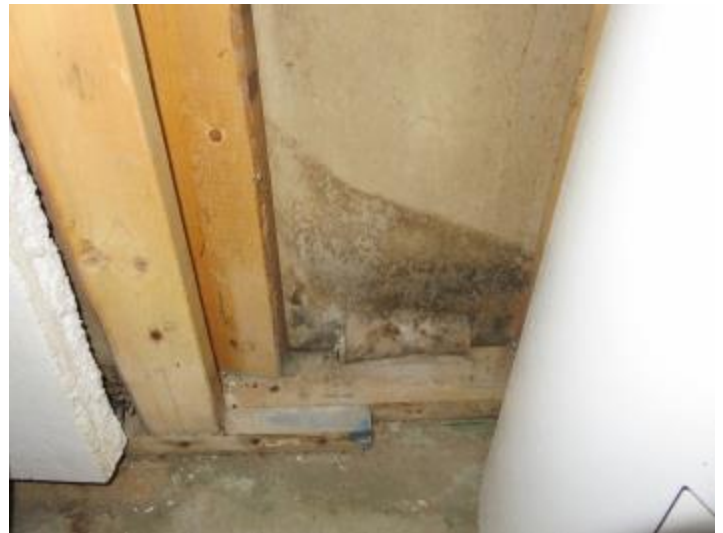
- Visible mold growth was observed at one or more locations within the basement furnace room area(s). It is beyond the scope of this inspection to identify what substance or organism this staining is. However such staining is normally caused by excessively moist conditions, which in turn can be caused by plumbing or building envelope leaks and/or substandard ventilation. These conducive conditions should be corrected before making any attempts to remove or correct the staining. Normally affected materials such as drywall are removed, enclosed affected spaces are allowed to dry thoroughly, a mildewcide may be applied, and only then is drywall reinstalled. For evaluation and possible mitigation, consult with a qualified industrial hygienist or mold/moisture mitigation specialist.

**Figure 24** Mold in Basement Furnace Room

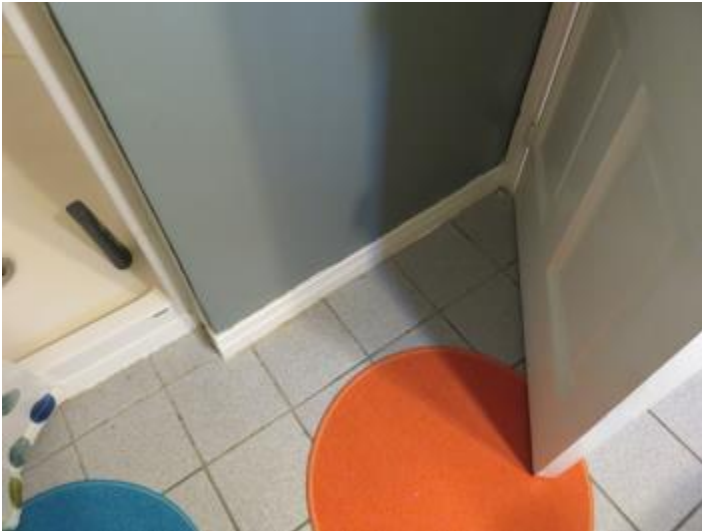
- Stains were observed in one or more wall locations within the basement bathroom area(s). However, no elevated levels of moisture were found. The stain(s) may be due to a past plumbing leak. Consult with the property owner and monitor the stained area(s) in the future, especially after heavy or prolonged rain. If elevated moisture is found in the future, then recommend that a qualified contractor evaluate and repair as necessary.

**Figure 25** Water Damage in Basement Bathroom

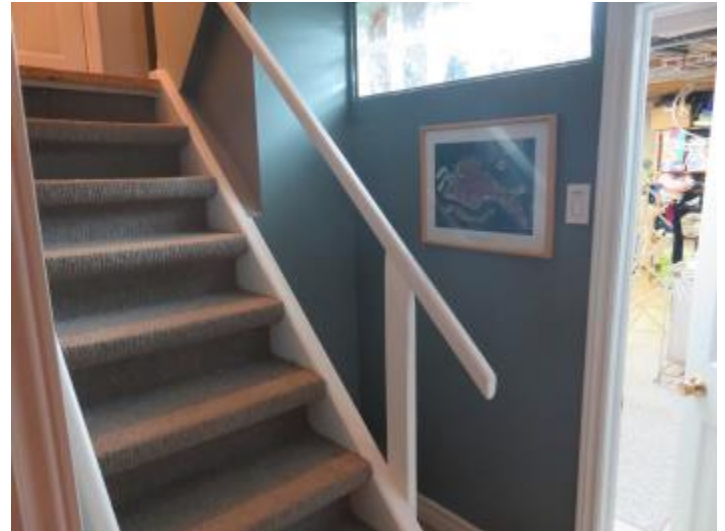
- The basement stairway(s) were observed to be missing balusters at open sides. This is a potential fall hazard, especially for small children that can crawl through the exposed opening(s). Recommend that a qualified contractor install balusters where missing and per standard building practices.

**Figure 26** Basement Handrail(s) Missing Baluster(s)

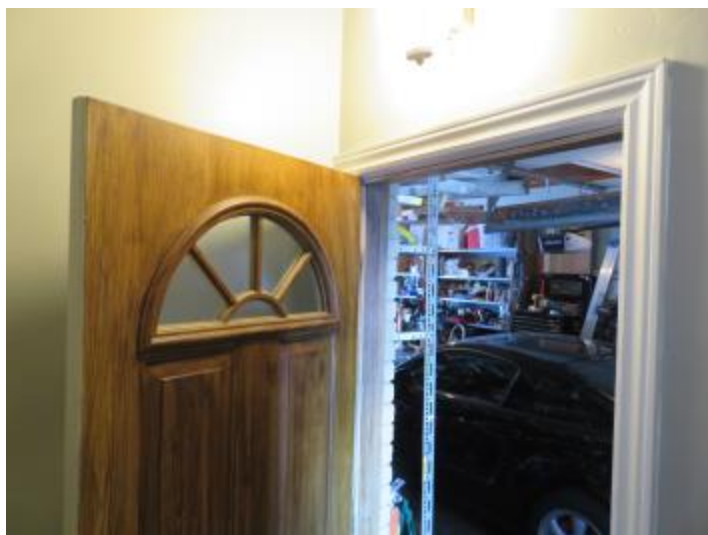
- One or more door between the garage and the house were observed to be missing a self-closing device. These devices are installed to keep the door closed to prevent possible fire and fumes from the garage from spreading to the house. Recommend that a qualified person repair as necessary.

Figure 27 Entry Door(s) Missing Self-Closing Device(s)

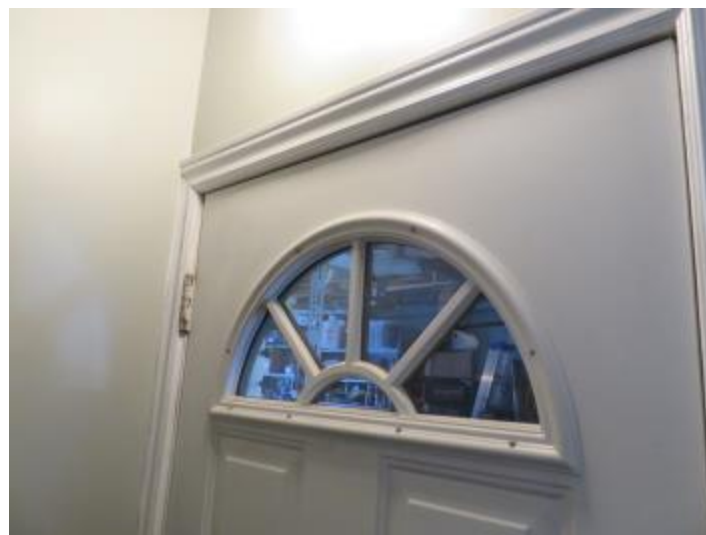
- The door between the garage and the house did not appear to be fire resistant, or the inspector was unable to verify that it was via a label. This is a potential safety hazard. House to garage doors, to prevent fire and fumes from spreading from the garage into interior living space, should be constructed of fire-resistant materials. Doors, generally considered to be suitable for the purpose, are solid core wood, steel, honeycomb steel or a door that has been factory labeled as fire rated. Recommend that a qualified contractor replace or repair the door and, at that time, make any other corrections that might be required to provide suitable fire resistance between the garage and the dwelling per standard building practices.

Figure 28 Entry Door(s) Not Fire-Resistant
