HOME INSPECTION REPORT

123 SAMPLE STREET

ANYWHERE, ONTARIO

Inspection Date: **November 29, 2016**

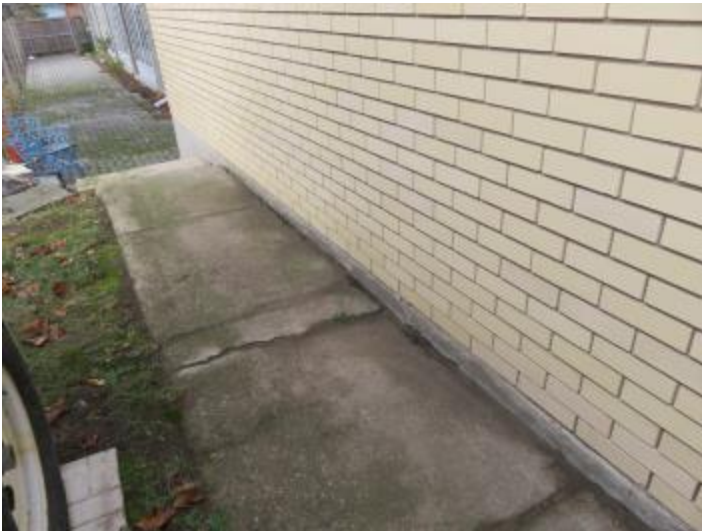
- Minor deterioration (e.g. cracks, holes, settlement, heaving) was observed in the walkway(s) located at the SW side(s) of the building. You may wish to have repairs made for cosmetic reasons and we recommend monitoring these areas over time. For safety consideration, any cracks that develop into potential tripping hazards should be repaired.

Figure 1 SW Walkway Minor Deterioration

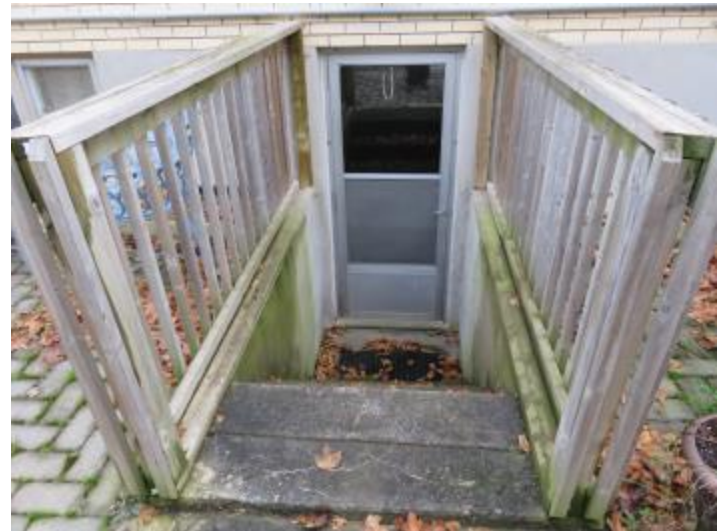
- Handrails at the back stairway were observed to be missing. This is a potential fall hazard. Handrails should be installed at stairs with four or more risers or where stairs are greater than 30 inches high. Recommend that a qualified contractor install handrails where missing and per standard building practices.

Figure 2 Back Stairway Missing Handrail(s)

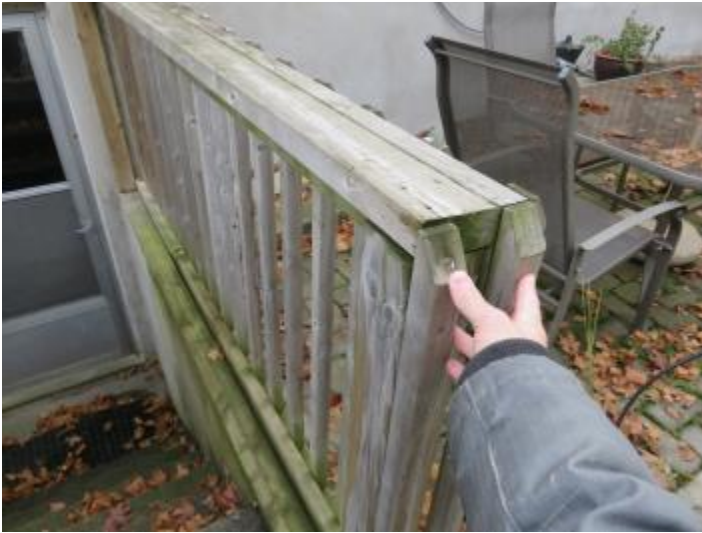
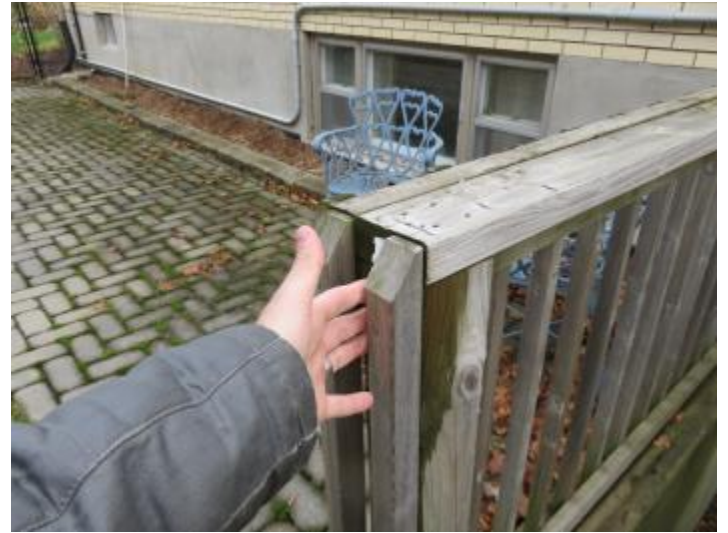
- Handrails or guards at the back stairway were observed to be loose, damaged or substandard, and pose a fall hazard. Recommend that a qualified person repair or replace as necessary.

Figure 3 Back Stairway Loose Guard(s)

Figure 4 Back Stairway Loose Guard(s)

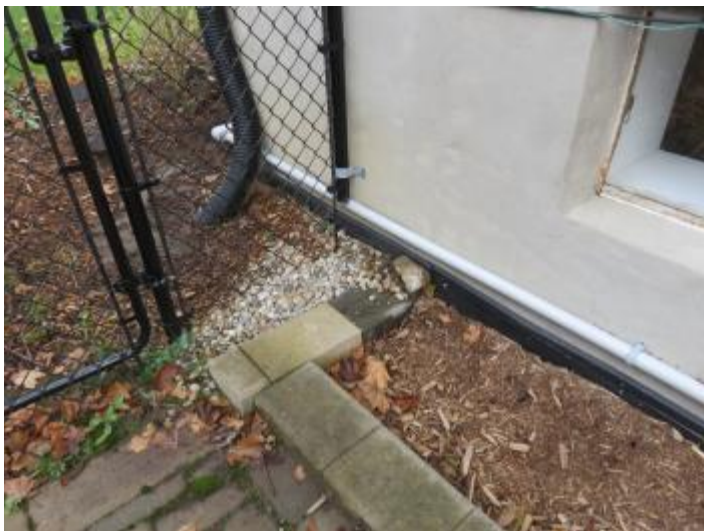
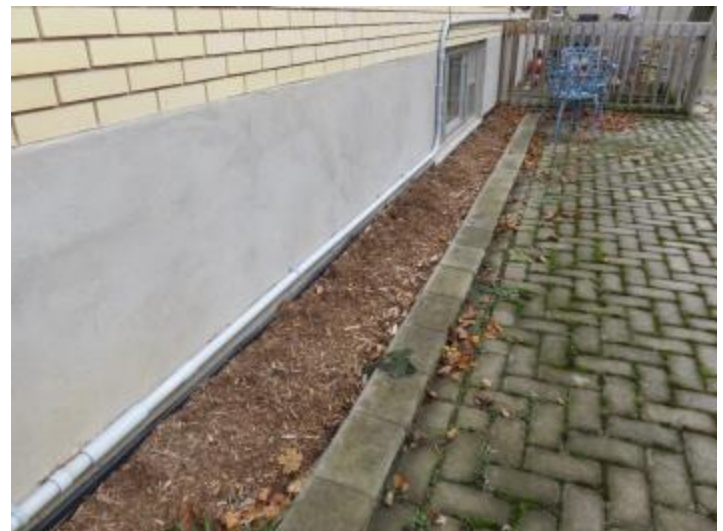
- Evidence of a water-proofing system (e.g. plastic or rubber membrane) was observed along the back exterior foundation walls. This may be an indication that water has accumulated in the basement in the past. Consult with the property owner and/or reviewing disclosure statements. Also monitor the basement for accumulated water in the future. The inspector did not determine if drainage issues have or haven't been resolved and does not guarantee or warrant that water will not accumulate in the basement in the future.
-

Figure 5 Exterior Waterproofing at Back of Building

Figure 6 Exterior Waterproofing at Back of Building

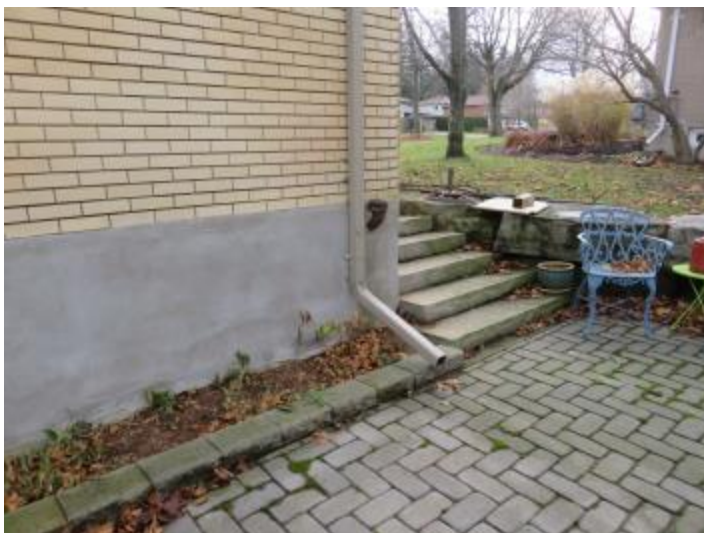
- One or more downspouts or downspout extensions located at the NW side(s) of the property, were observed to drain onto walkways. This can result in ice or moss forming on walkways, and can pose a fall hazard. Recommend that a qualified person install or modify extensions as necessary so rainwater isn't directed onto walkways.

Figure 7 NW Downspout Discharges onto Walkway

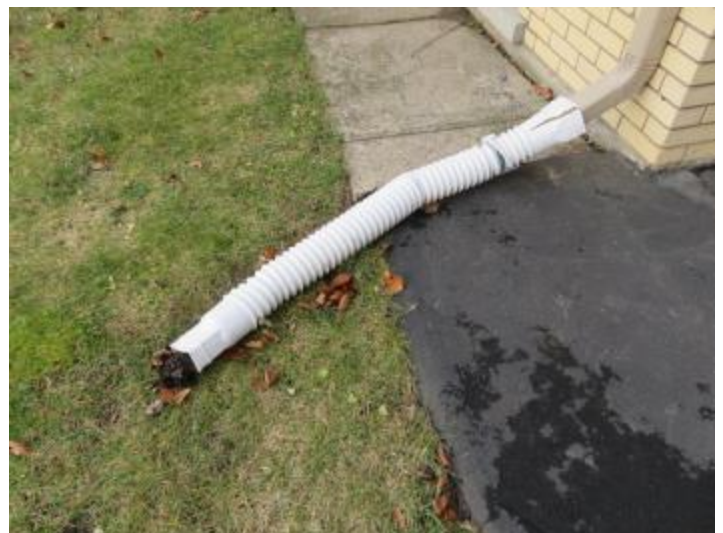
- Significant amounts of debris were observed to have accumulated in one or more gutters or downspouts located at the SW corner(s) of the building. Gutters can overflow and cause water to come in contact with the building exterior, or water can accumulate around the foundation. Gutters and downspouts often clog with debris. Screens or deflectors are sometimes installed to prevent leaves and twigs from getting into the troughs. These rarely work well. They become loose and often fall out. They also make cleaning more difficult. Special screens are available for the top of downspouts to prevent the entry of debris. These work better, but still must be cleaned regularly. Recommend cleaning gutters and downspouts now and as necessary in the future.

Figure 8 Debris in SW Downspout

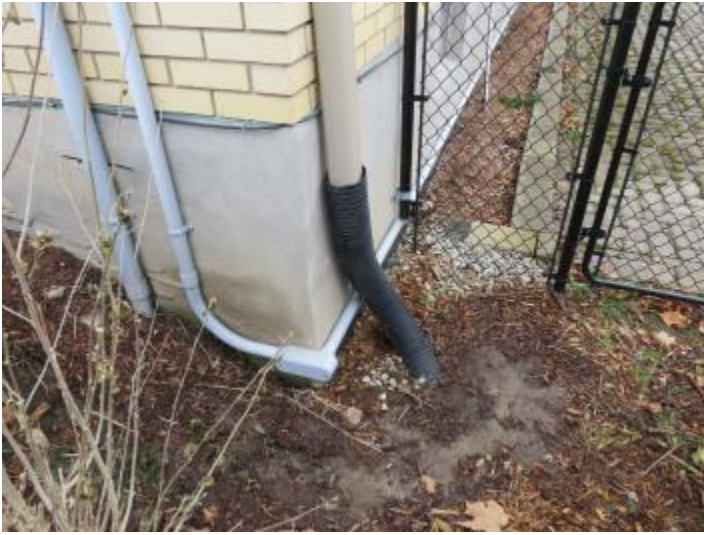
- One or more downspouts located at the NE corner(s) of the building, were observed to be discharging below grade. Downspouts which discharge below grade do not leave the below grade portions visible for inspection. Recommend monitoring these areas during rainstorms to evaluate adequacy of below grade drainage or a better solution would be to abandon all below grade sections and instead add extensions of at least 4 to 6 feet to discharge water down and away from the foundation of the building.

Figure 9 NE Downspout Discharges Below Grade

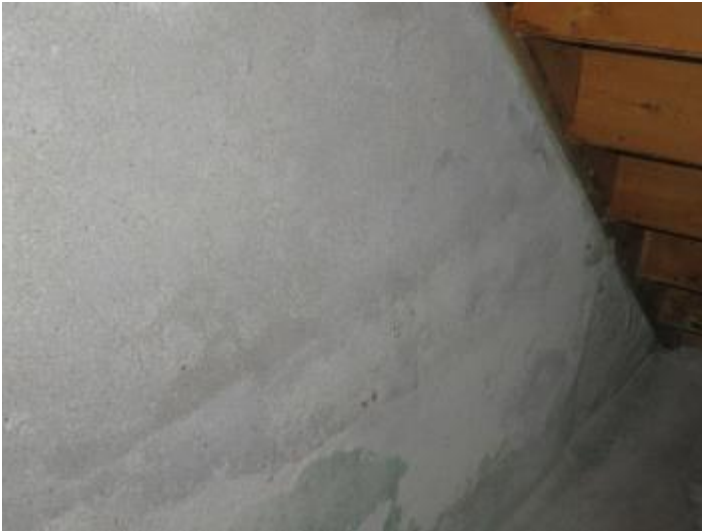
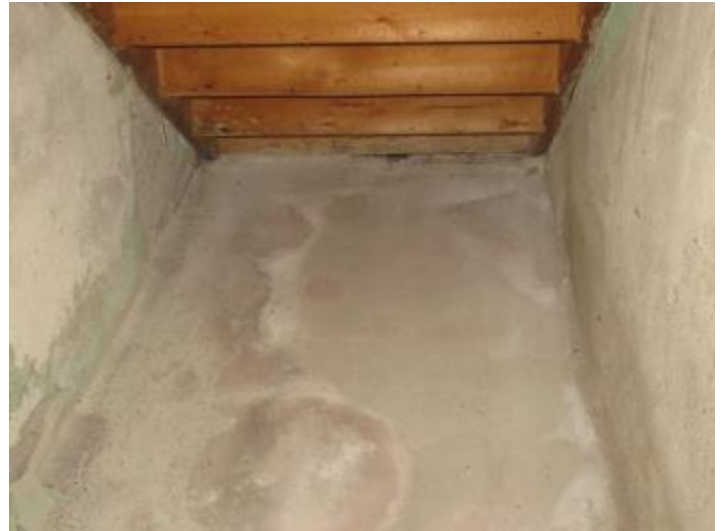
- Evidence of prior water intrusion was observed along the SW interior foundation wall(s). For example, water stains or rust at support post bases, efflorescence on the foundation, etc. Accumulated water is a conducive condition for wood-destroying organisms and mold growth and should not be present in the basement. Recommend reviewing any disclosure statements available and ask the property owner about past accumulation of water in the basement. The basement should be monitored in the future for accumulated water, especially after heavy and/or prolonged periods of rain. If water is found to accumulate, then recommend that a qualified contractor who specializes in drainage issues evaluate and repair as necessary.
-

Figure 10 Evidence of Moisture SW Wall(s)

Figure 11 Evidence of Moisture SW Wall(s)

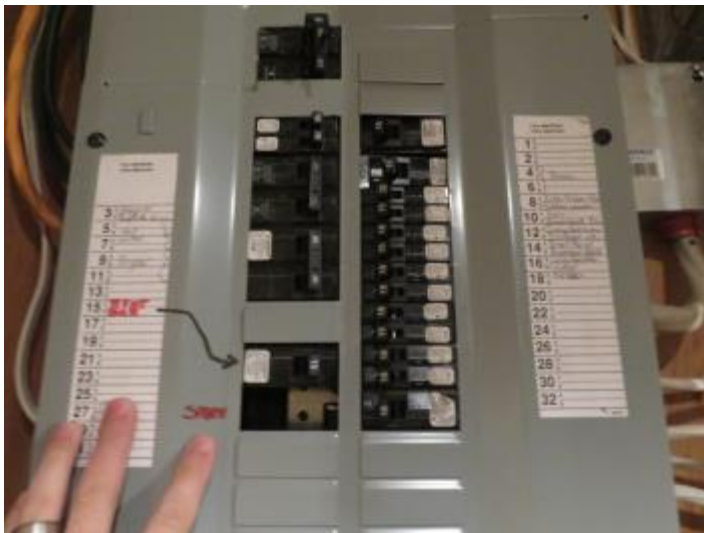
- One or more slots where circuit breakers are normally installed were observed to be open in the main service panel(s). Energized equipment was exposed and is a shock hazard. Recommend that a qualified person install closure covers where missing.

Figure 12 Open Slot(s) at Main Service Panel

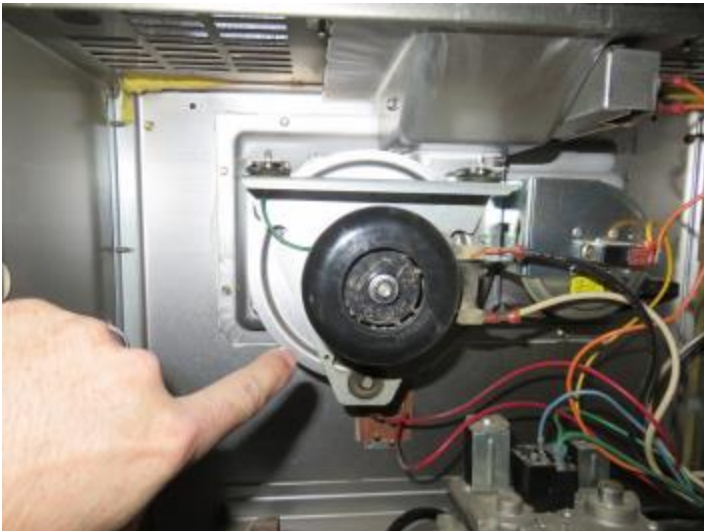
- The circulating and/or inducer fan(s) for the forced air heating system(s) was observed to be noisy or vibrating excessively. Recommend that a qualified HVAC contractor evaluate and repair as necessary.

Figure 13 *Furnace Inducer Fan Noisy*

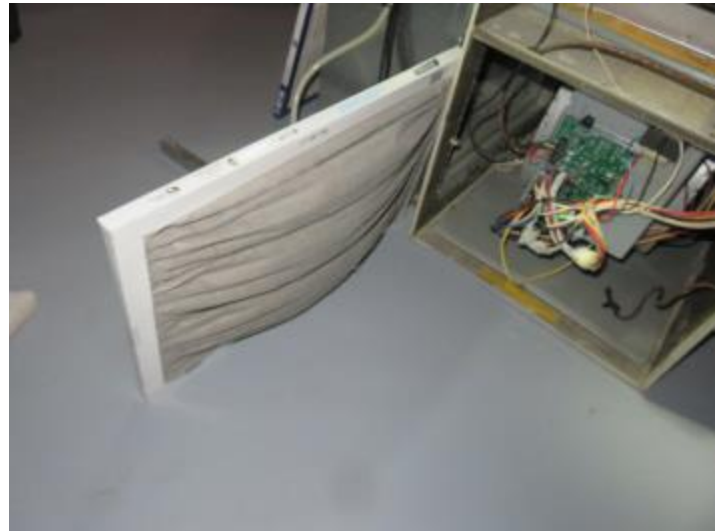
- One or more furnace filters were observed to be in need of replacement or cleaning. Recommend replacing or washing HVAC filters upon taking occupancy depending on the type of filters installed. Regardless of the type, recommend checking filters monthly in the future and replacing or washing them as necessary. How frequently they need replacing or washing depends on the type and quality of the filter, how the system is configured (e.g. always on vs. "Auto"), and on environmental factors (e.g. pets, smoking, frequency of house cleaning, number of occupants, the season).

Figure 14 *Recommend Replacing Furnace Filter*

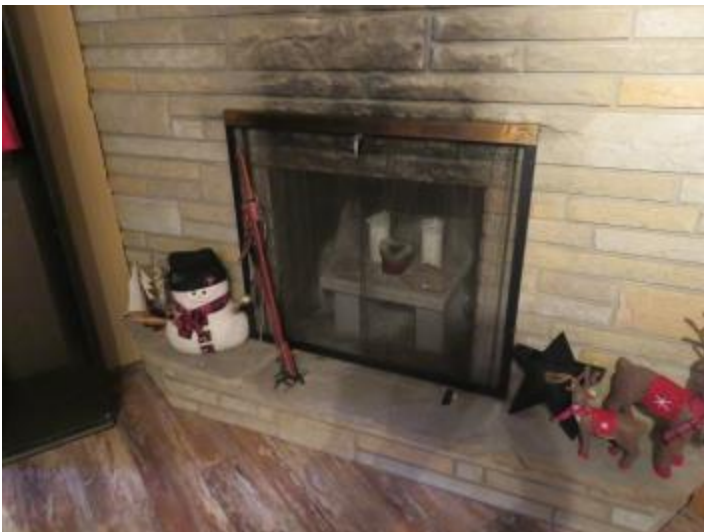
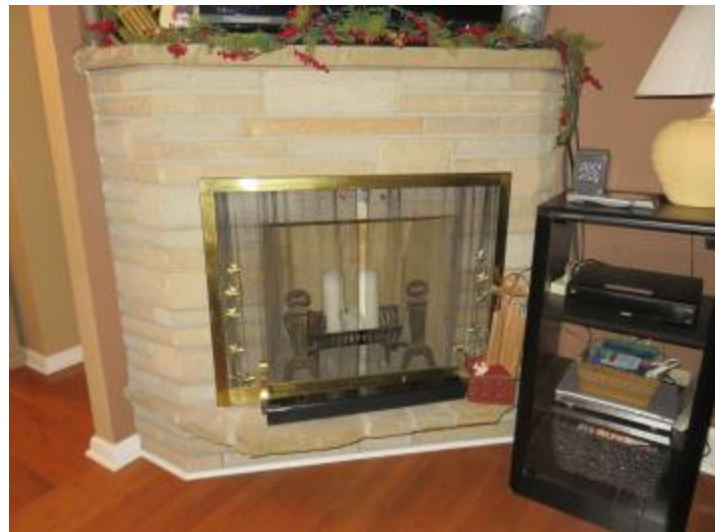
- One or more wood-burning fireplaces or stoves were observed at the property. When such devices are used, they should be professionally inspected and cleaned annually to prevent creosote build-up and to determine if repairs are needed. A chimney inspection should be performed with every sale or transfer of property with a wood-burning device. Recommend consulting with the property owner about recent and past servicing and repairs to all wood-burning devices and chimneys or flues at this property. Recommend that a qualified specialist evaluate all wood-burning devices and chimneys, and clean and repair as necessary. Note that if a wood stove insert is installed, it may need to be removed for such an evaluation.

Figure 15 *Recommend Specialist Evaluate Fireplace*

Figure 16 *Recommend Specialist Evaluate Fireplace*

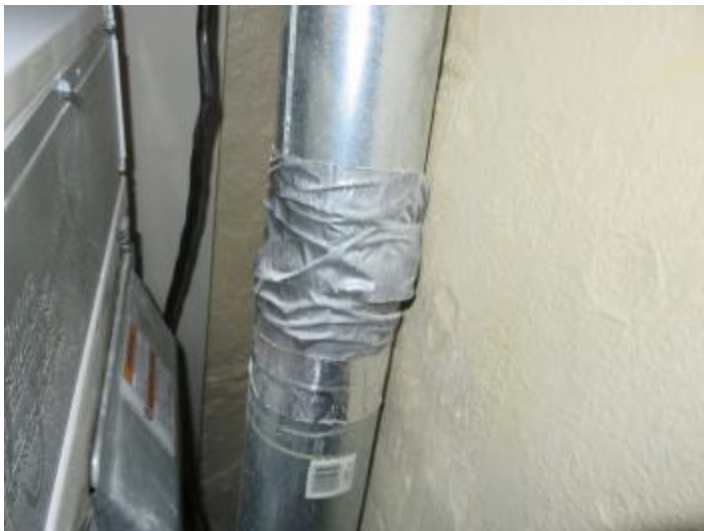
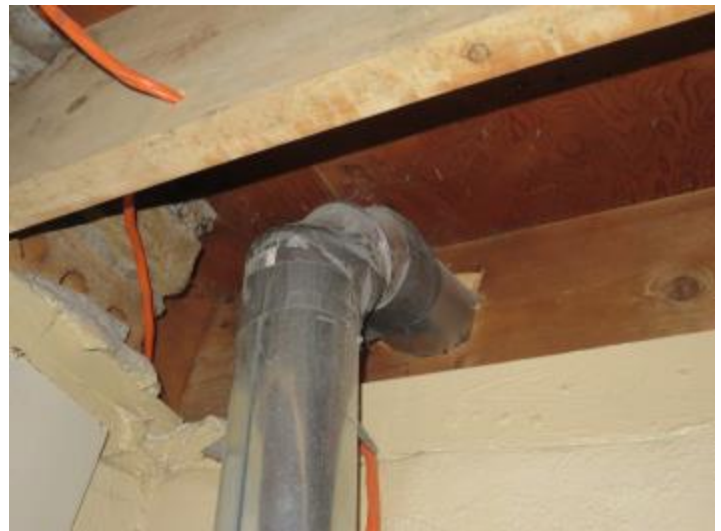
- Duct tape was observed to be used at various joints for the clothes dryer exhaust duct(s). Clothes dryers produce large amounts of heat which can ignite flammable materials. This is a potential fire hazard. Recommend replacing duct tape with aluminum foil tape designed for ductwork.
-

Figure 17 Duct Tape at Dryer Vent Joint(s)

Figure 18 Duct Tape at Dryer Vent Joint(s)

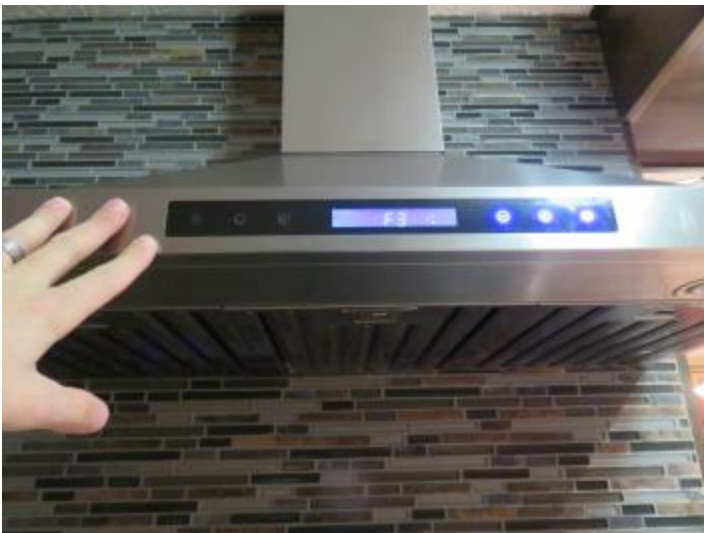
- The kitchen ventilation fan(s) or range hood(s) was observed to be noisy or vibrated excessively. Recommend that a qualified person repair or replace as necessary.

Figure 19 Range Hood Fan(s) Noisy/Vibrating

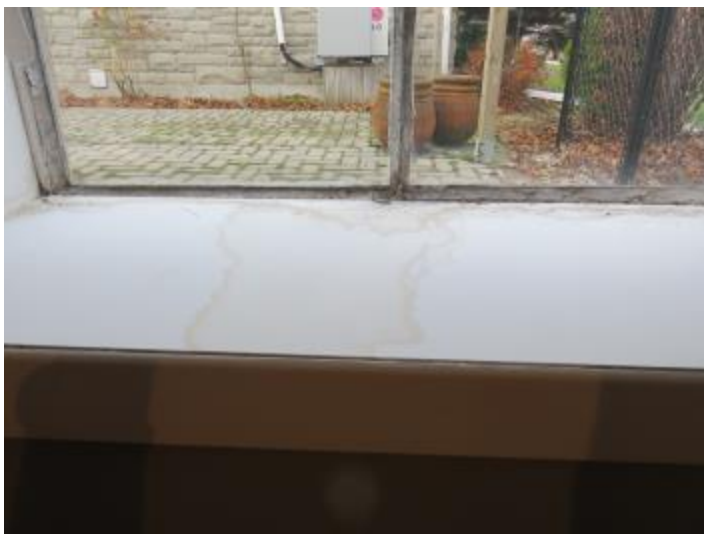
- Trim or jambs around one or more exterior windows was observed to have staining which may be a sign of prior moisture intrusion through the window(s). Recommend monitoring for future moisture accumulation and that a qualified person repair, replace or install as necessary.

Figure 20 *Staining at NE Basement Window*

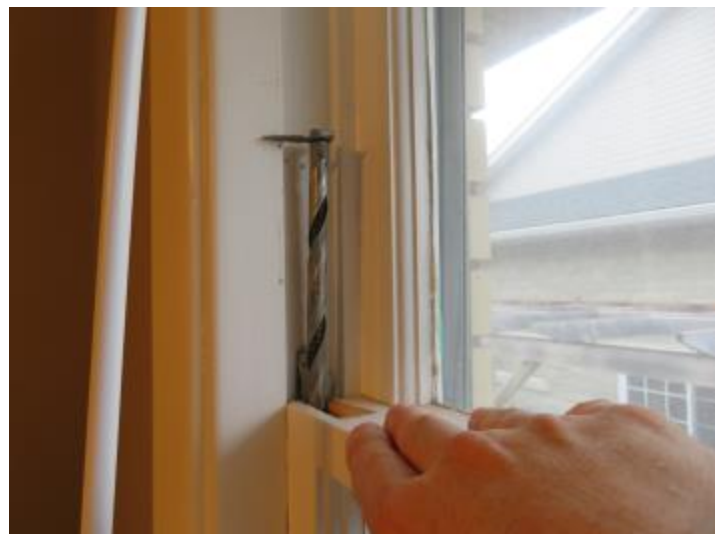
- One or more windows along the NW wall(s) of the main level office/bedroom that were designed to open and close were observed to be damaged, stuck shut or difficult to open and close. Recommend that a qualified person repair windows as necessary so they open and close easily.
-

Figure 21 *NW Office/Bedroom Window(s) Damaged*

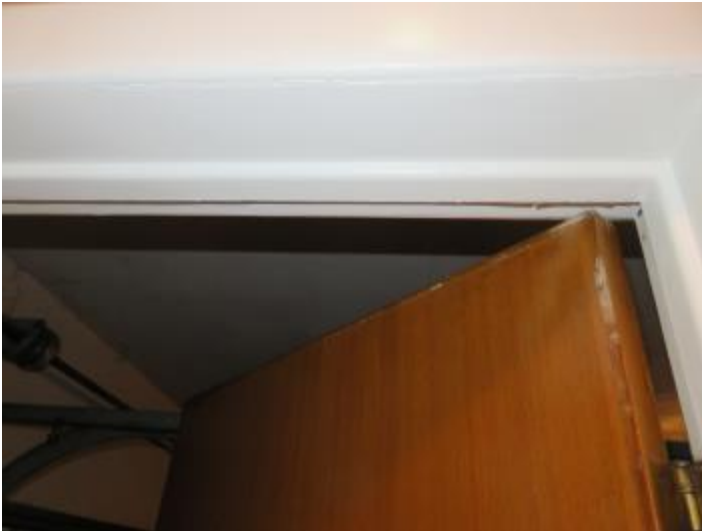
- One or more doors between the garage and the house were observed to be missing a self-closing device. These devices are installed to keep the door closed to prevent possible fire and fumes from the garage from spreading to the house. Recommend that a qualified person repair as necessary.

- One or more doors between the garage and the house did not appear to be fire resistant, or the inspector was unable to verify that it was via a label. This is a potential safety hazard. House to garage doors, to prevent fire and fumes from spreading from the garage into interior living space, should be constructed of fire-resistant materials. Doors, generally considered to be suitable for the purpose, are solid core wood, steel, honeycomb steel or a door that has been factory labeled as fire rated. Recommend that a qualified contractor replace or repair the door and, at that time, make any other corrections that might be required to provide suitable fire resistance between the garage and the dwelling per standard building practices.

Figure 22 Entry Door not Fire-Resistant/Missing Closer

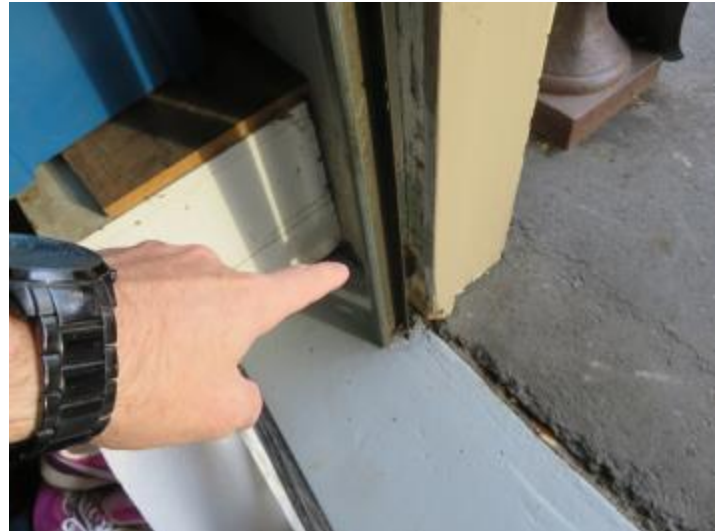
- No photoelectric sensors were observed to be installed for one or more garage vehicle doors' automatic openers. These have been required on all automatic door openers since 1993 and improve safety by triggering the door's auto-reverse feature without need for the door to come in contact with the object, person or animal that is preventing the door from closing. Recommend that a qualified contractor install photoelectric sensors where missing for improved safety.
-

Figure 23 Vehicle Door(s) Missing Sensor(s)

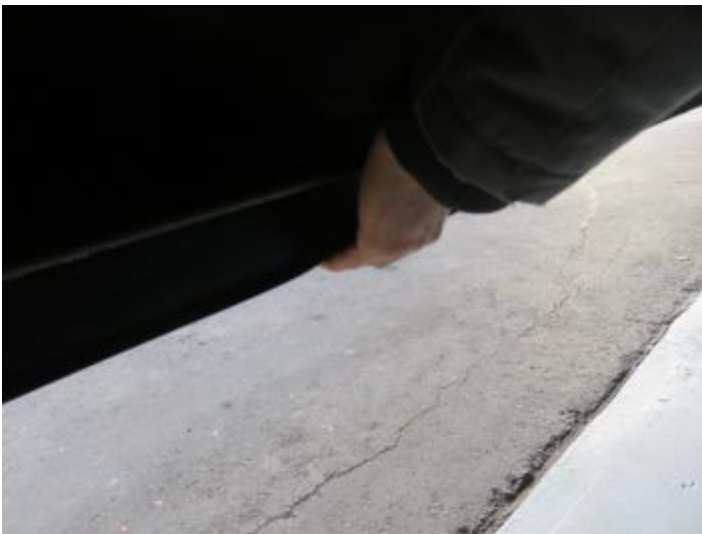
- The auto-reverse mechanism on one or more automatic openers for garage vehicle doors was observed to be inoperable or required excessive force. This is a potential safety hazard. A qualified contractor should evaluate and repair as necessary.

Figure 24 Adjust Vehicle Door Auto-Reverse Settings
